Transport and Road Research Lab.  
Crowthorne (England)

1981

**TRRL LABORATORY REPORT 970**

**THE KENYAN LOW COST MODULAR TIMBER BRIDGE**

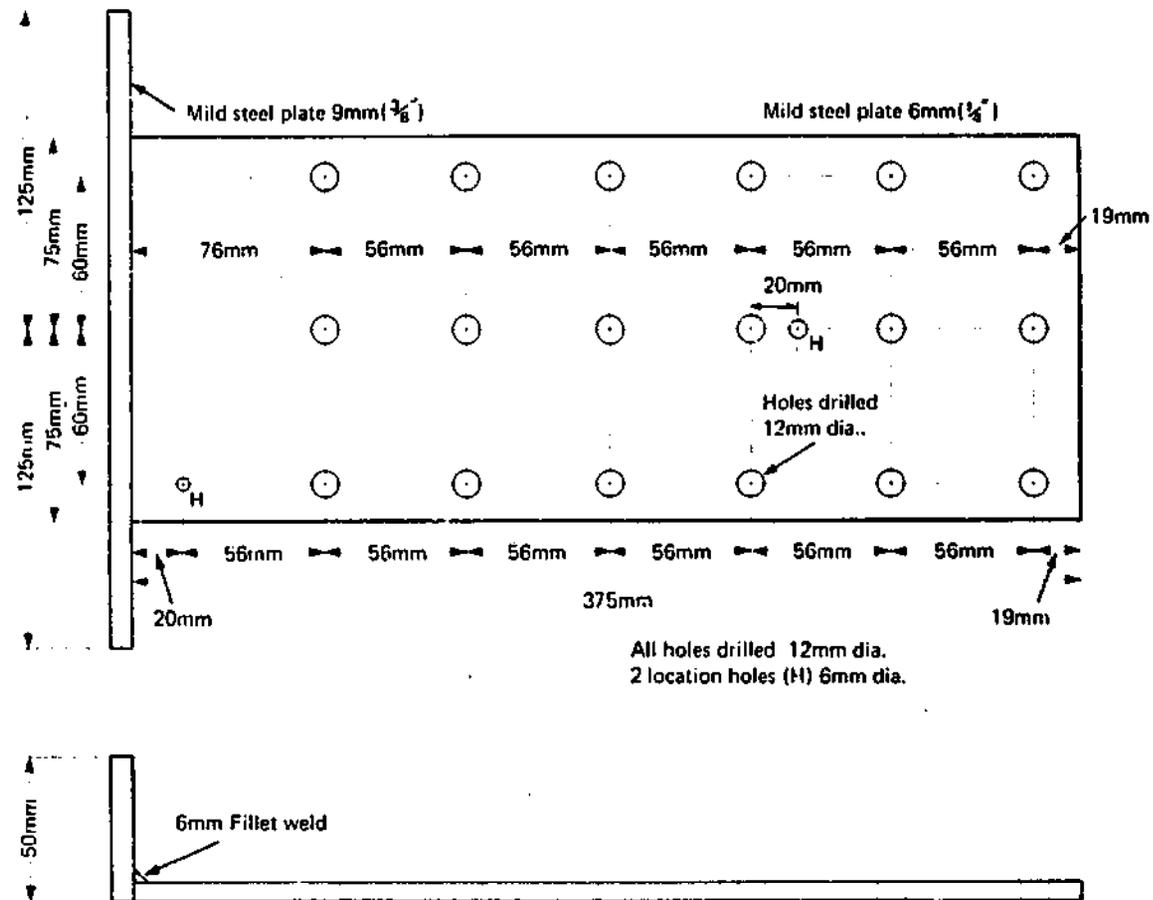
Fig. 6 TOP PLATE

Steel dowels are used to join the timber members at each corner of the frame. The two top joints are identical, each consisting of two steel plates (Figure 6) one on each side, through which the dowels pass, penetrating through the horizontal timber member and then into the diagonal. There is no connection through the joint but the two top steel plates are joined when the end plate (Figure 7) is welded across them; a male end plate at one end of the frame and a female at the other.

Although the location of the dowel holes in the drilled plates (Figures 6 and 8) is not very critical, a template for the pilot drilling saves time marking out and gives a consistent result. The 40 mm holes in the bottom chords (Figure 3) should be drilled accurately using a template.

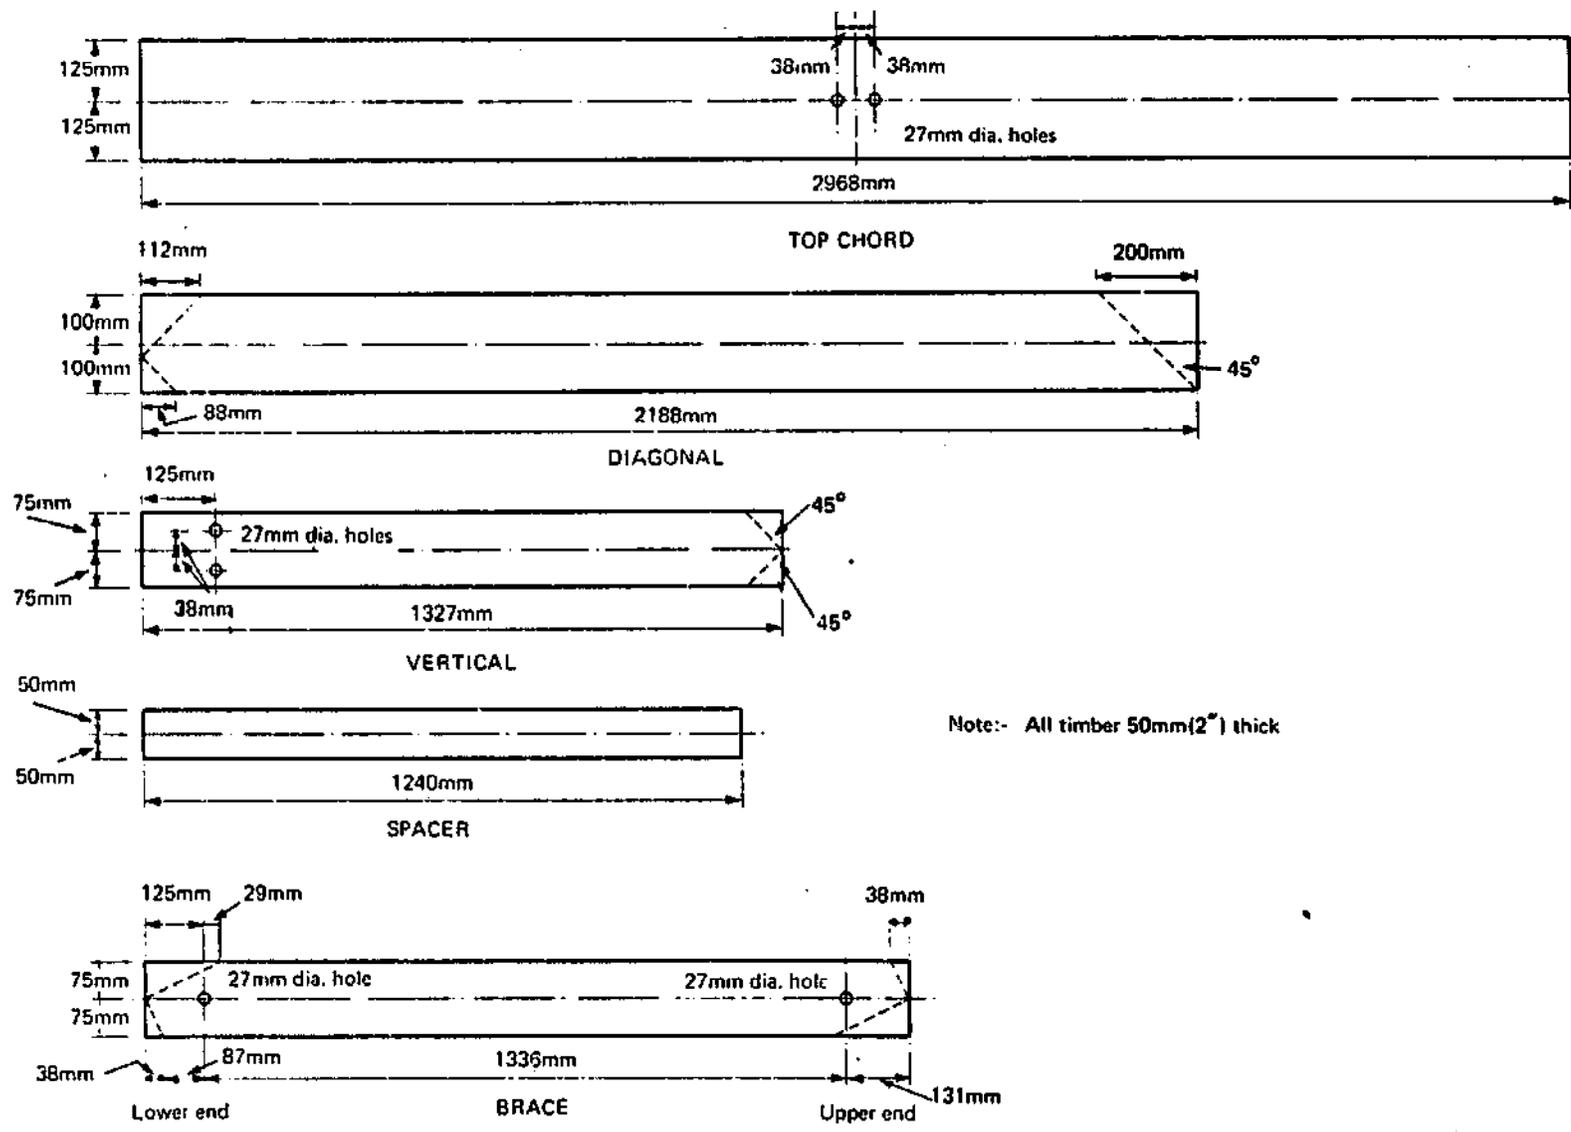
Fig. 5 TIMBER MEMBERS

All the timber is of 50 mm nominal thickness and the depths of the frame members vary from 100 to 250 mm according to their duty (Figure 5). Each timber member comprises two identical pieces of timber which are nailed together back-to-back, except the top chords which are separated by 100 mm spacers. The advantages of this double section design are:-

The timber members of the frame are cut to the dimensions shown in Figure 5. It is important that lengths and angles are cut accurately, and for this reason it is recommended that simple jigs are used at this stage. Of equal importance is an assembly jig to ensure that all the frames are assembled to give constant length, depth between centres of the locating pins (1343 mm), and squareness of the end plates. The vertical struts should not project above the top surface of the top chords.

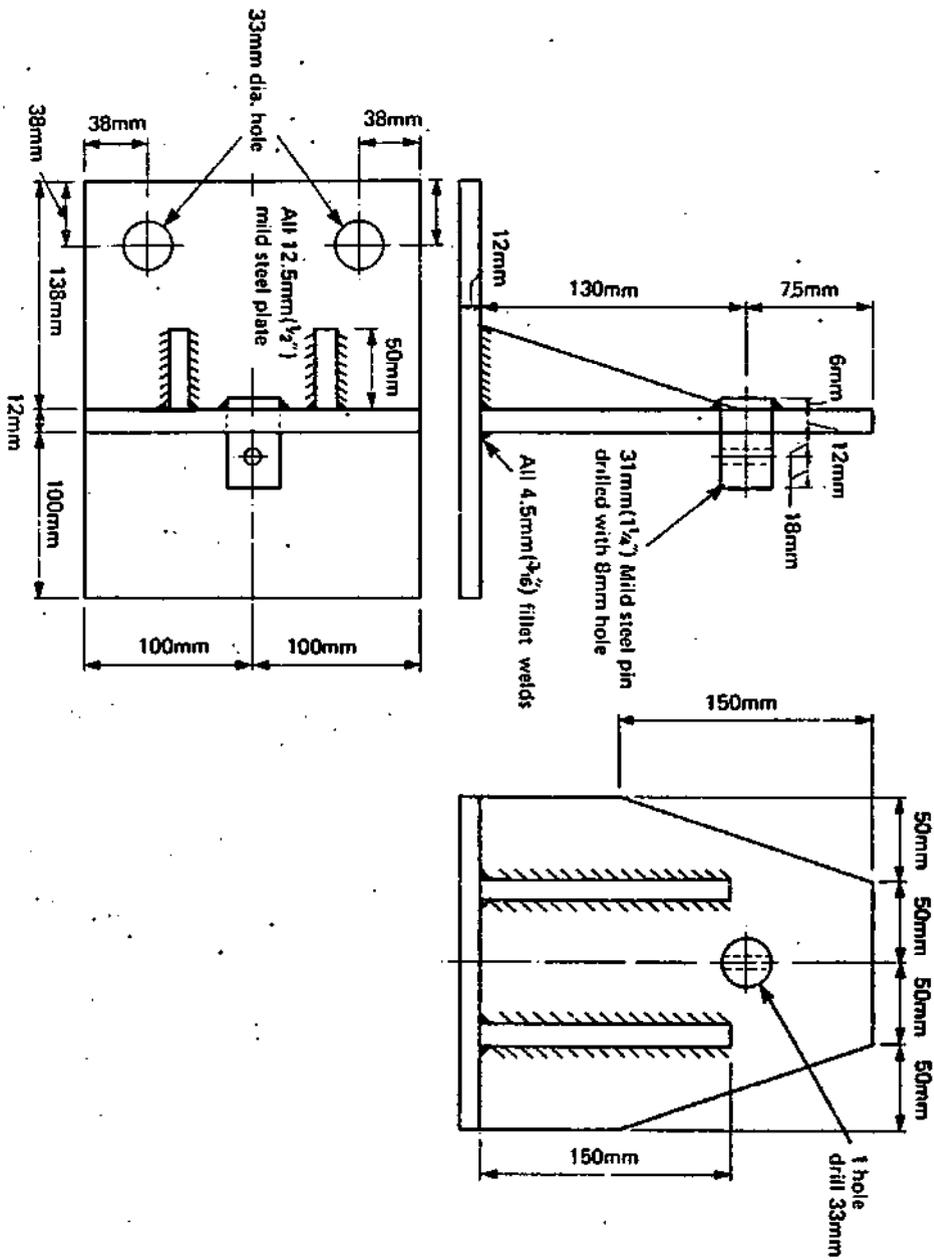
Fig. 4 BRIDGE BEARING (MALE). (BRIDGE BEARING (F) SIMILAR BUT 31mm(1 1/4 in) DIA. PIN OMITTED

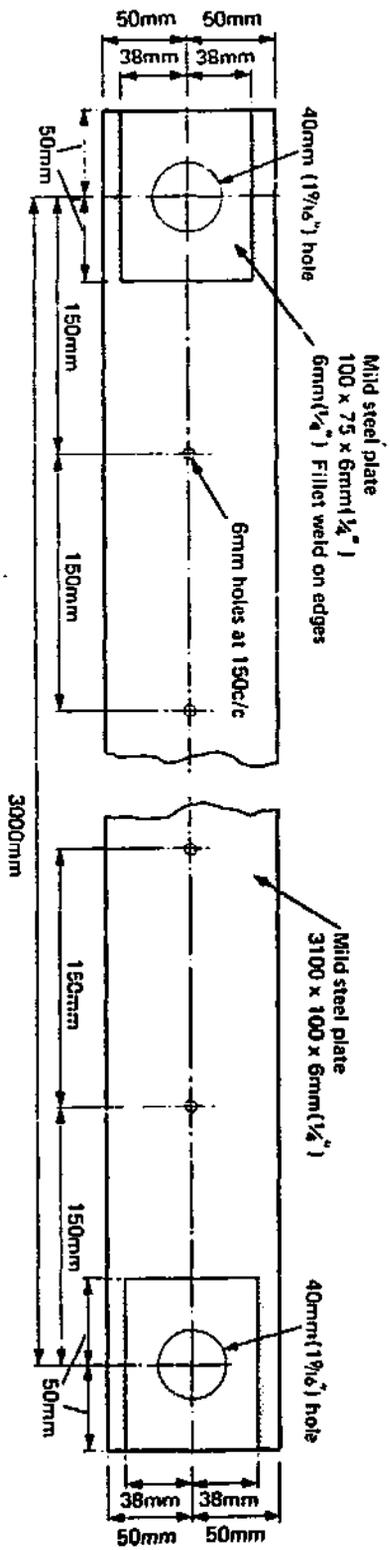
Fig. 3 BOTTOM CHORD

Each truss is assembled from a number of identical frames (Figure 2), prefabricated and transported to the site together with the steel bottom chords (Figure 3). The frames are made of rough sawn softwood boards 50 mm thick, dowelled and nailed together to form an inverted triangle 3 metres long with a vertical brace. They weigh about 140 kg each and are all made in the same manner. Practical considerations limit the number of frames in a truss from 3 or 4 to about 8 or 10, according to the properties of the timber employed.

- (ii) the distance between hole centres in the bottom chords (Figure 3) and
- (iii) the squareness of the end plates (Figure 7) that butt together when the frames are assembled end to end.

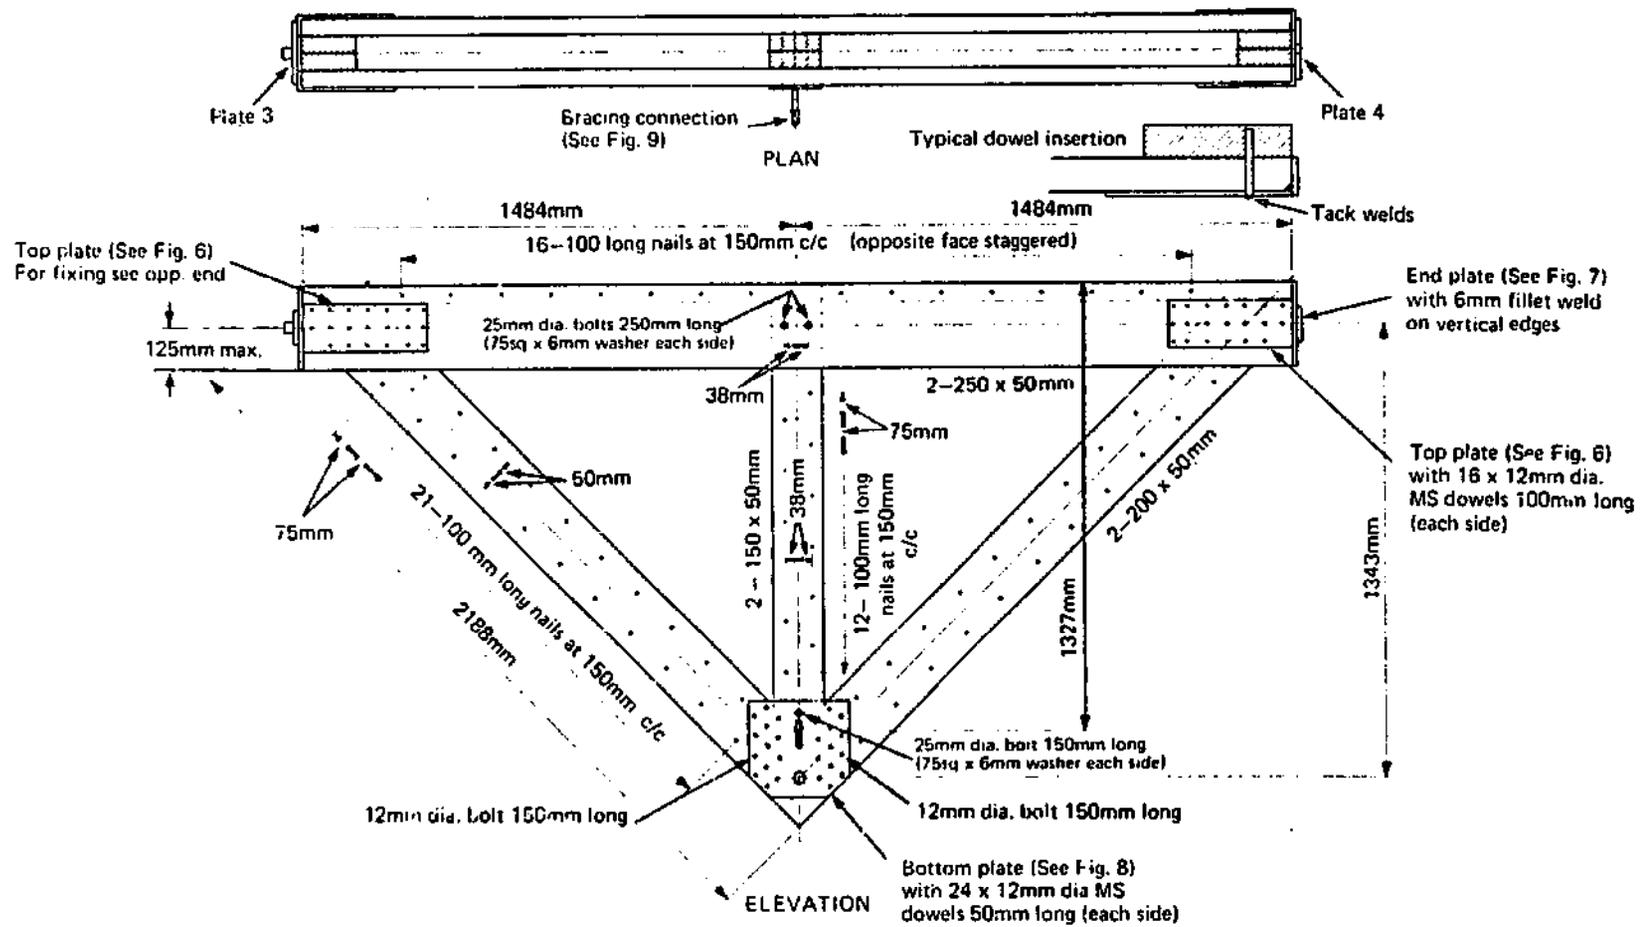
Fig. 2 FRAME ASSEMBLY

Figure 2 details the frame on which this bridge design is based. The top horizontal chords are always in compression whereas most diagonal members take both compressive and tensile loads. On the end frames of each truss however, one diagonal member will be permanently in tension and the other in compression. The vertical members are under load only when the frame to which they belong is underneath a superimposed load. The pin locating the end frame to the bridge bearing carries the largest shear force on the truss into the end joint of the frame.

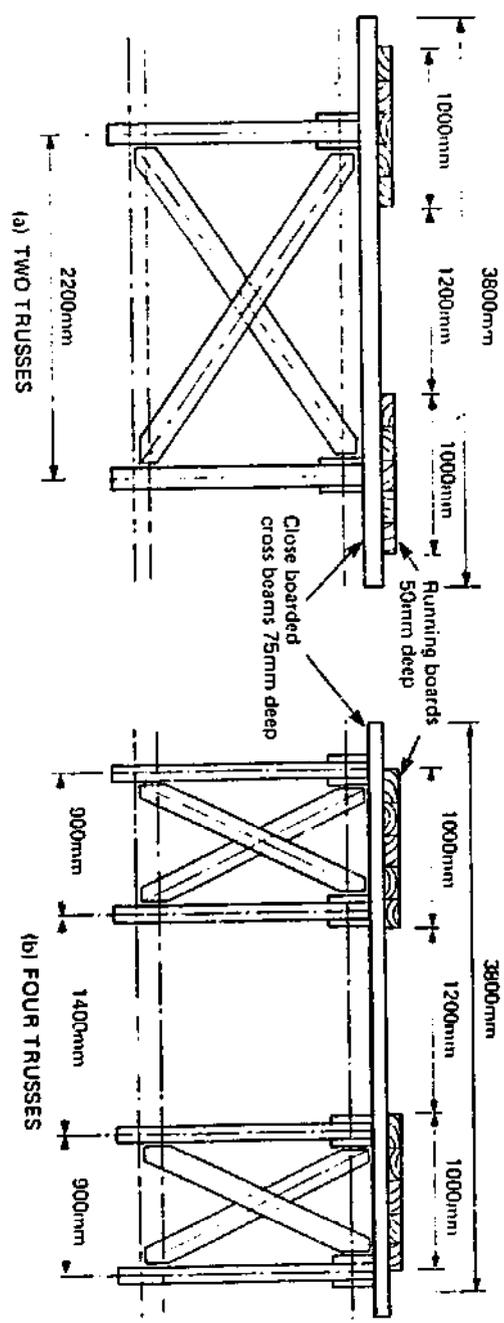
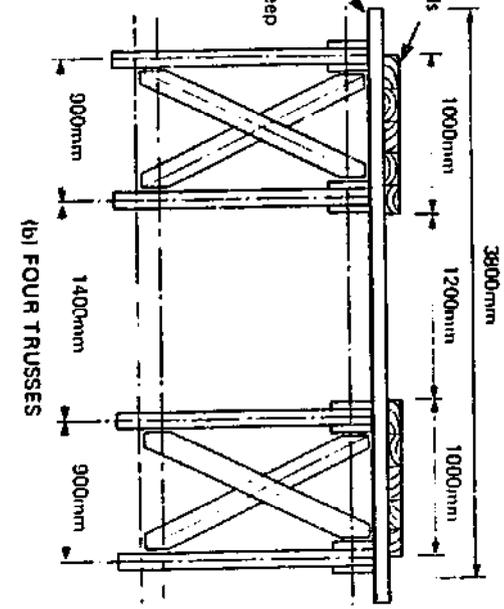
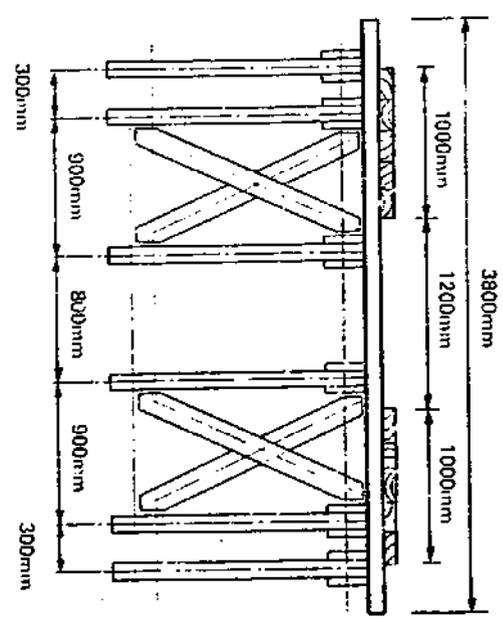
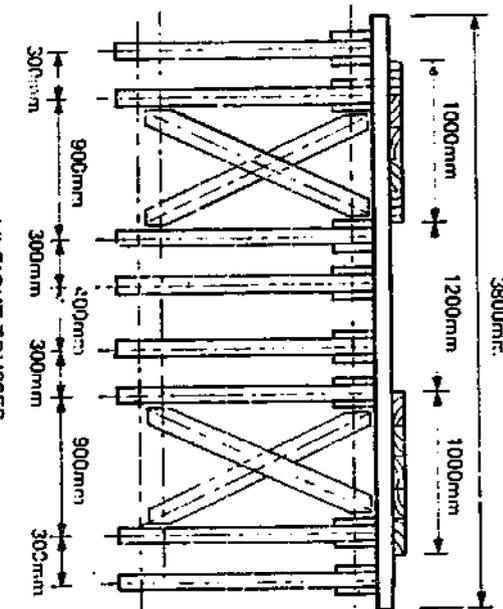
In a typical bridge, four trusses are positioned side-by-side, but the number of trusses can range from two to eight depending on the loading requirements (see Figure 1).

Fig. 1 TYPICAL CROSS-SECTIONS USING (a) TWO TRUSSES (b) FOUR TRUSSES (c) SIX TRUSSES (d) EIGHT TRUSSES

The vertical cross-bracing shown in Figure 1, and the close boarded cross beams provide a large measure of lateral stability. In addition sway bracing is achieved by attaching long wooden members diagonally in a horizontal plane to the underside of the top chords and at bottom chord level. The vertical braces are attached to the top chord using a bracket (Figure 9) and are bolted to the lug on the bottom plate (Figure 8). The lower sway braces may be bolted to the bottom plates with the lug turned through 90° or may be nailed to the wooden spacers between the bottom chords.

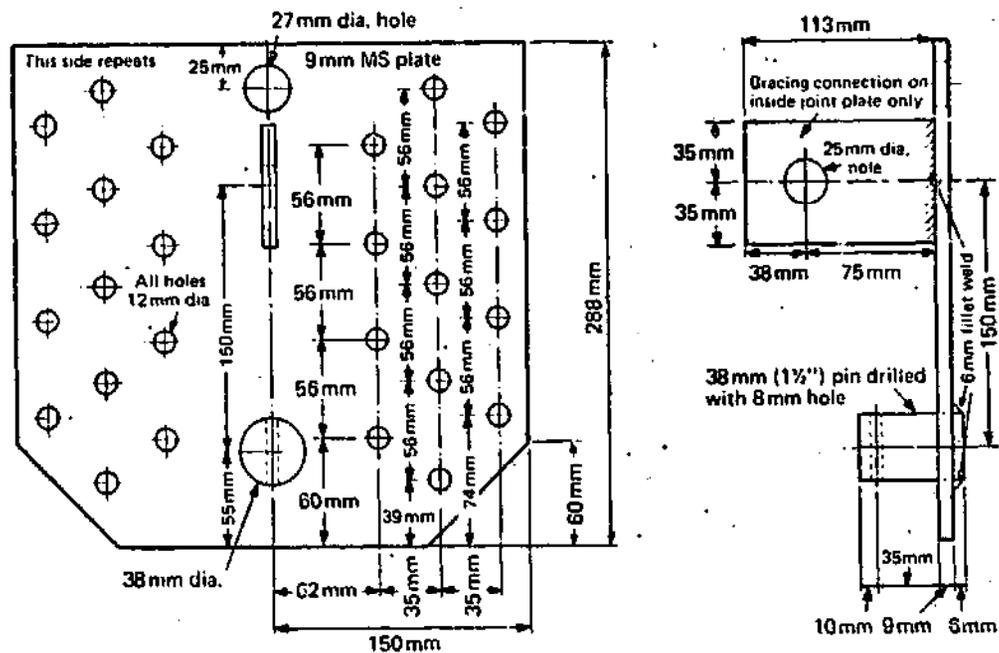
Fig. 8 BOTTOM PLATE

In the bottom joint, the two diagonal members are not joined by the dowels but each is dowelled to the bottom plates (Figure 8). Again similar plates are used each side of the joint and dowels are driven through them and into the timber from each side. In addition two through-bolts hold the plates in place. The vertical member is restrained by one bolt which also passes through both plates. The top of this member is held between the horizontal chords by two through-bolts. These bolts convey the load from the horizontal chord to the vertical member and so down to the bottom joint of the frame.

- (i) the location of the pins in the bottom plate (Figure 8) or the positioning of the plate on assembly of the frame,

Two important aspects of this design are its simplicity and cheapness of manufacture. To this end, all the frames are virtually identical; the only variation being different versions of the bottom plate (Figure 8) according to bracing requirements.

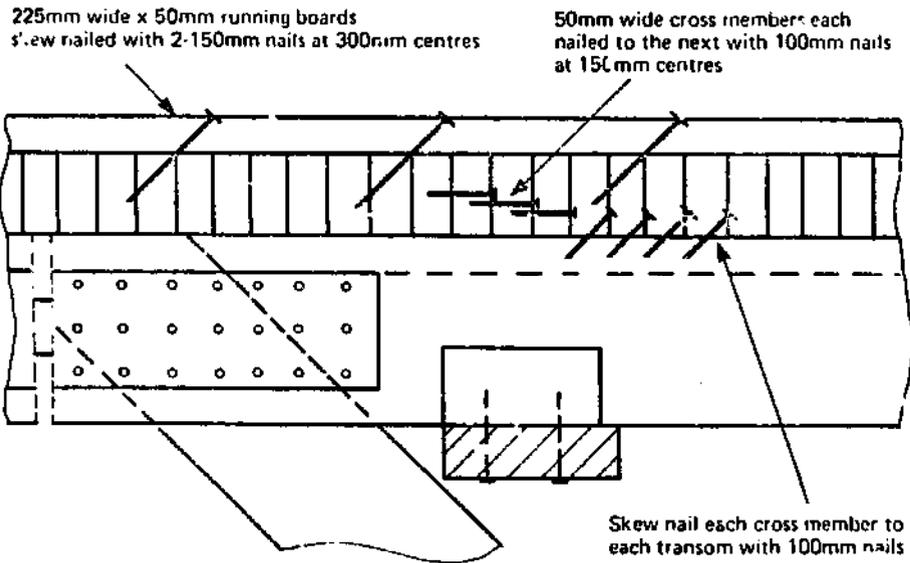
Fig. 10 DETAIL OF DECK

Of several designs tried by Mr Collins for the deck the use of close nailed cross beams was preferred. This puts a large dead weight on the trusses (than using transoms or spaced cross beams) but it also increases the bending resistance of the whole bridge. In this design the deck is a stress-carrying part of the assembly and it should be assembled to the trusses as shown in Figure 10. This type of deck is still popular for timber bridges in the USA. The cross beams used in Kenya are 75 mm or 100 mm deep. They are nailed into the spacing timbers between the top chords of the frames and to each other (Figure 10). Running boards, 50 mm deep are attached by nails or coach bolts to the cross beams. These running boards may be replaced when worn without disturbing the structure.

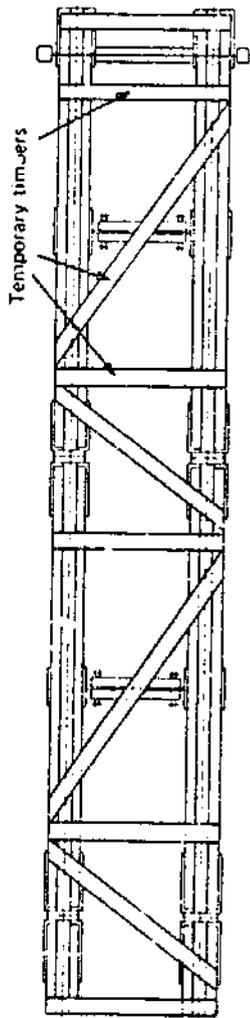
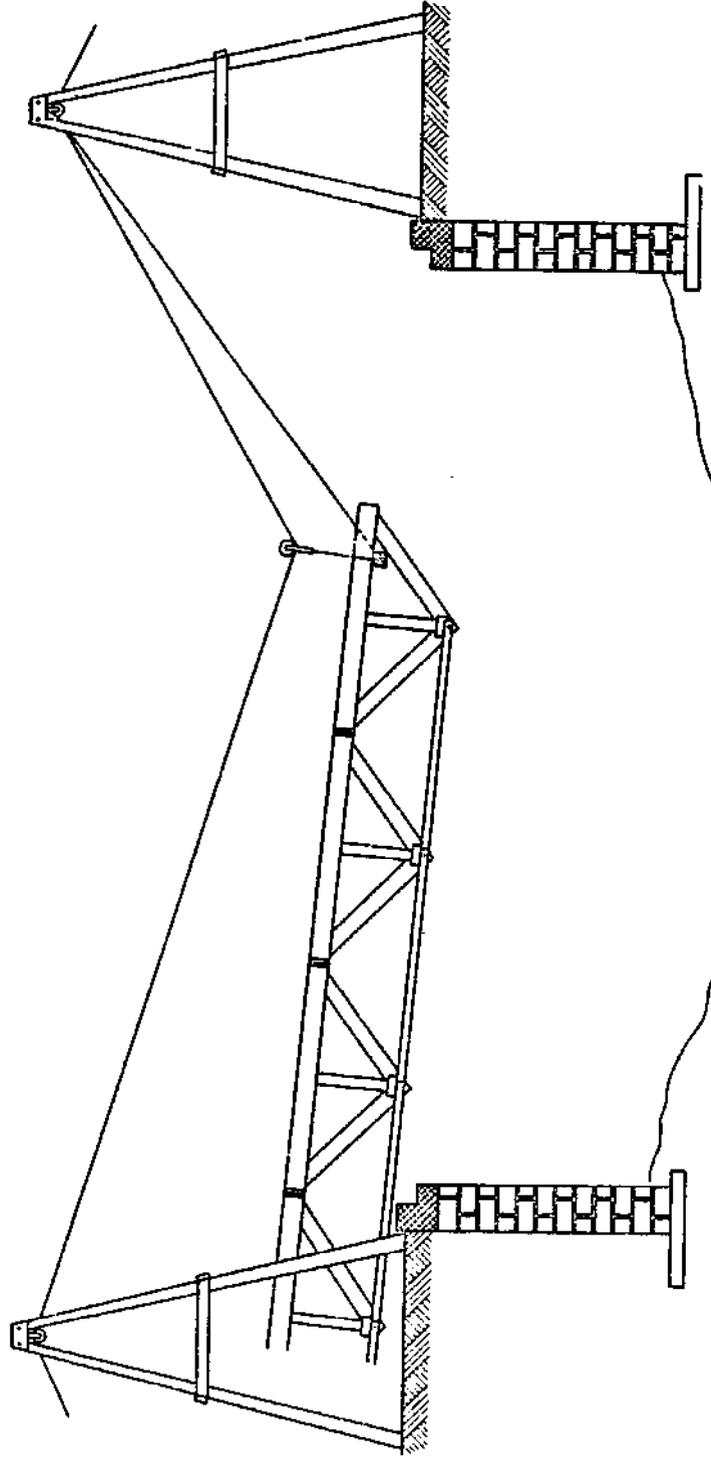
Fig. 11 LAUNCHING A PAIR OF TRUSSES

The first bridge constructed at Isiolo was built by hand, with each frame being bolted into position in its final place. This was done in the dry season and the method would not be practical for a crossing with deep water or across a ravine. Subsequent bridges were built without support from below using a timber derrick on each abutment with a wire rope stretched between them. The truss was then built up at one abutment and launched across the river; this was done in stages adding further frames until the full truss length was reached (Figure 11).

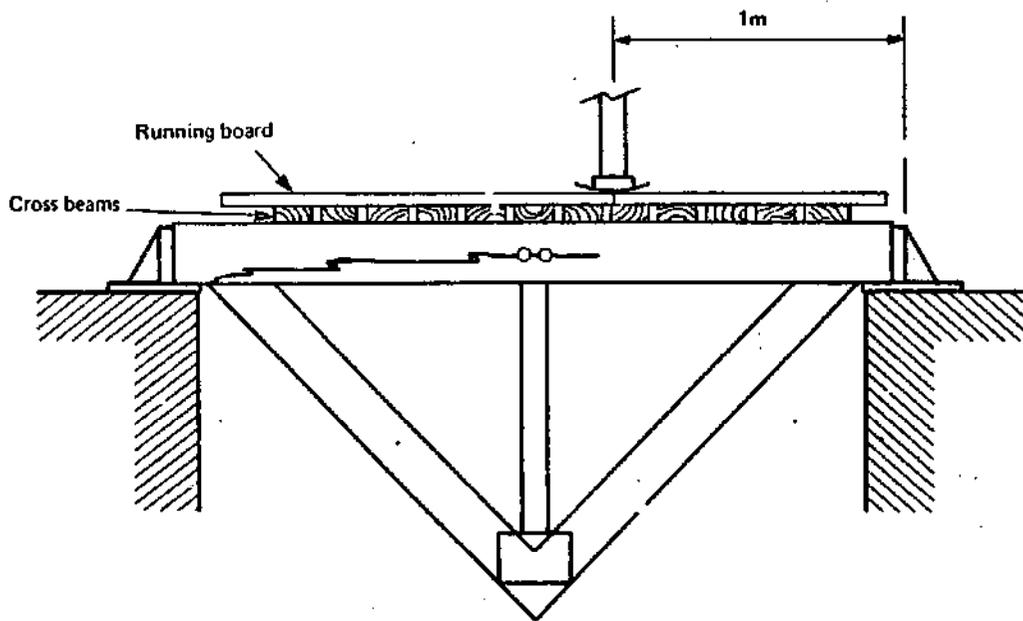
Fig. 12 TEST LOADING A SINGLE FRAME

In all four cases the frames failed when a split was opened in one of the horizontal members across the bolt holes at its centre. This split progressed away from the load point under further loading until it broke out near the end of the member, either into the dowel holes or into the lower surface. The failure occurred gradually and in all cases the frame continued to sustain the load that caused the horizontal member to split. A greater load, or several applications of the same load, were required to cause the second horizontal member to fail. The moisture content of the timbers measured with a resistance meter ranged from 15 per cent to 17 per cent. The results are summarised in Table 1.

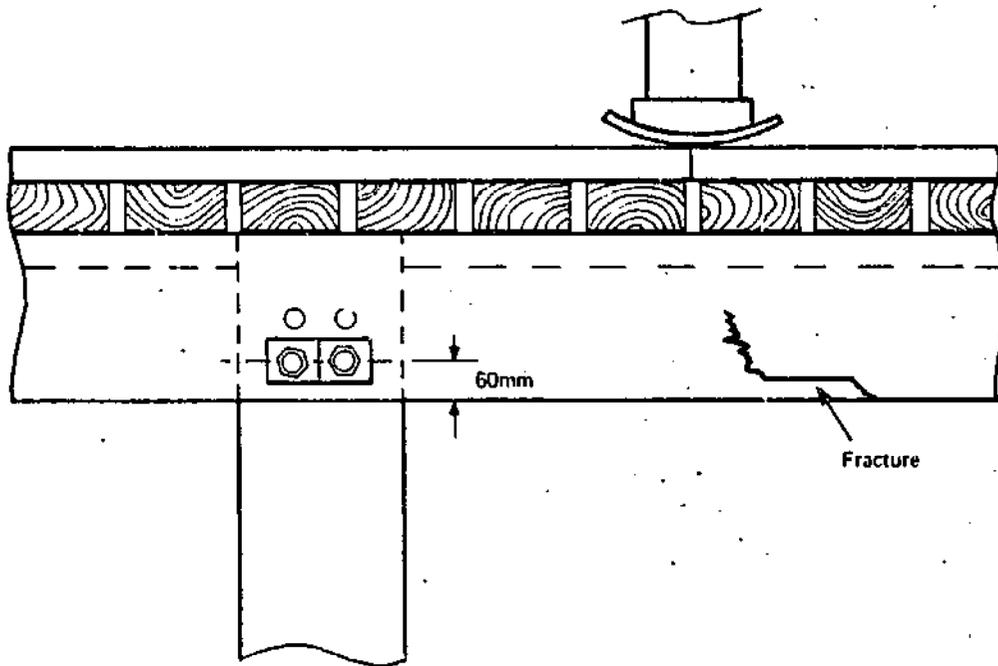
Fig. 13 FRAME MODIFICATIONS

In order to obtain better use of the strength of the horizontal members of the frame, the four failed units were repaired using new timber for the horizontals. The two bolts that caused the splitting were removed from the holes on the centre line of the horizontal members and placed 60 mm from the lower edge as shown in Figure 13.

- (iii) Placing the two bolts on the centreline of the horizontal members causes unnecessary weakening. This may be avoided by positioning these bolts 60 mm from the lower edge of these members.

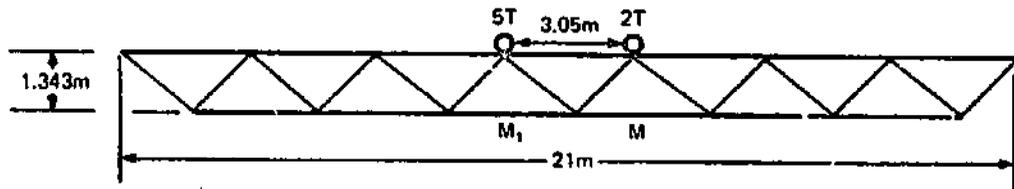
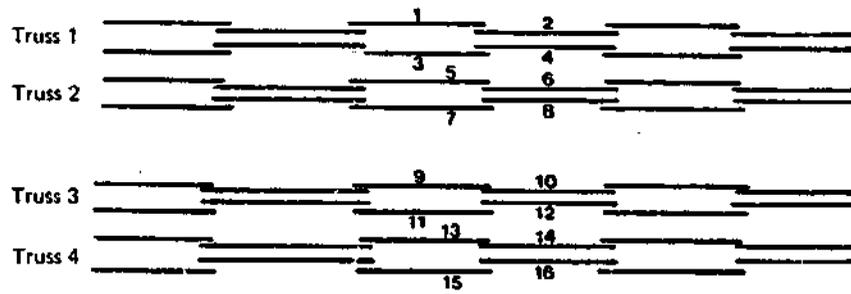
Fig.15 BRIDGE TESTS AT NYERI - BOTTOM CHORDS

In all three tests the measured maximum stress (a) was lower than was expected (b), and by a similar amount in each case. This is due to the contribution of the deck, which was ignored in the calculation of the theoretical stresses. If the two tests at Nyeri were carried out with similar accuracy it would seem that the contribution of the deck diminished between 1976 and 1979. This, if true, may be attributed to bedding in of the cross beams since a close examination of the bridge disclosed no loose joints.

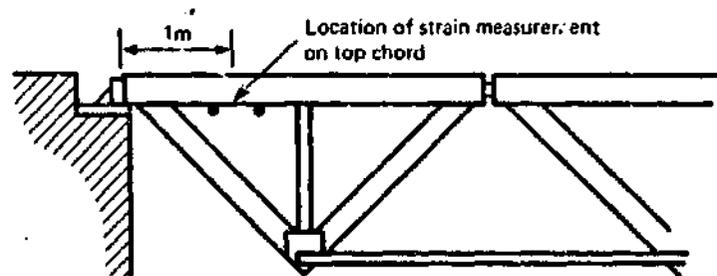
Fig.16 BRIDGE TESTS AT NYERI - TOP CHORDS

It is thought that the first bridge built at Isiolo failed when the horizontal top chords of the end frames broke, due to being repeatedly overloaded. Consequently strain measurements were taken with a demec gauge on the lower faces of four of the top chords of the bridge at Nyeri in 1979 (Figure 16). The results are shown in Table 7.
